**DEPARTMENT OF TRANSPORTATION**

Contract #: 04-0120F4Cty: SF/ALA Rte: 80 PM: 13.2/13.9File #: 1.28**WELDING INSPECTION REPORT****Resident Engineer:** Siegenthaler, Peter**Address:** 333 Burma Road**City:** Oakland, CA 94607**Report No:** WIR-020322**Date Inspected:** 07-Feb-2011**Project Name:** SAS Superstructure**OSM Arrival Time:** 800**Prime Contractor:** American Bridge/Fluor Enterprises, a JV**OSM Departure Time:** 1630**Contractor:** American Bridge/Fluor Enterprises, a JV**Location:** Jobsite**CWI Name:** See below**CWI Present:** Yes No**Inspected CWI report:** Yes No N/A**Rod Oven in Use:** Yes No N/A**Electrode to specification:** Yes No N/A**Weld Procedures Followed:** Yes No N/A**Qualified Welders:** Yes No N/A**Verified Joint Fit-up:** Yes No N/A**Approved Drawings:** Yes No N/A**Approved WPS:** Yes No N/A**Delayed / Cancelled:** Yes No N/A**Bridge No:** 34-0006**Component:** SAS OBG**Summary of Items Observed:**

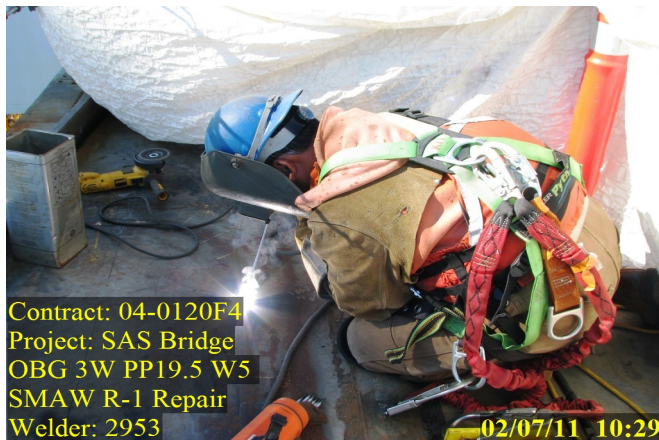
The QAI periodically observed AB/F approved welder Wai Kitlai (ID 2953) grinding to excavate and subsequently performing R-1 repair welding per the Shielded Metal Arc Welding (SMAW) process in the 1G (flat) position on the exterior of the DAH Insert Weld at OBG 3W PP19.5 W5. See photo below. QC Inspector Gary Ehram was present to monitor the progress and verify that the welding parameters were within the limits established by the approved welding Procedure Specification (WPS) identified as ABF-WPS-D1.5-1001 Repair. Welding of one excavated area was completed. The QAI observed the work at this location appeared to be in general compliance with contract documents. The QAI observed that the repair area excavated had the following dimensions and the following Y locations:

#1 - Y = 3820mm, Length = 100mm, Depth = 17mm, Width = 20mm.

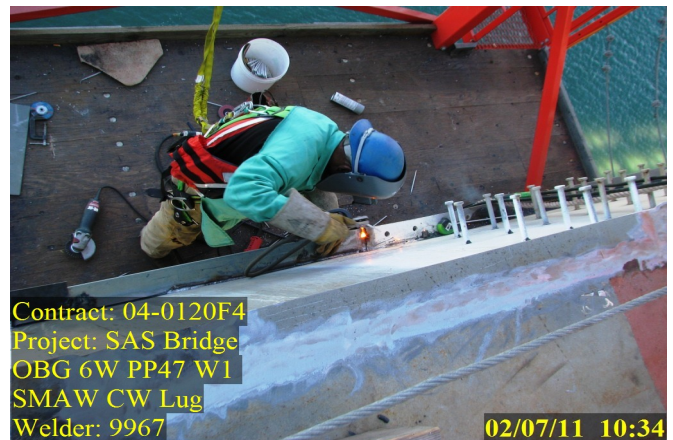
The QAI periodically observed AB/F approved welder Darcel Jackson (ID 9967) performing welding of a segment of a lower counterweight lug at 6W PP47 W1 per the Shielded Metal Arc Welding (SMAW) process in the 2G (horizontal) & 4G (overhead) positions. See photo below. QC Inspector Fred Von Hoff was periodically present to monitor the progress and verify that the welding parameters were within the limits established by the approved welding Procedure Specification (WPS) identified as ABF-WPS-D1.5-1080 rev 1. Welding and grinding was in process at this location. The QAI observed that the work appeared to be in general compliance with contract documents.
